DEPARTMENT OF TRANSPORTATION

Contract #: 04-0120F4Cty: SF/ALA Rte: 80 PM: 13.2/13.9File #: 99.28**WELDING INSPECTION REPORT****Resident Engineer:**Siegenthaler, Peter**Address:** 333 Burma Road**City:** Oakland, CA 94607**Report No:** WIR-020793**Date Inspected:** 18-Nov-2010**Project Name:** SAS Superstructure**OSM Arrival Time:** 700**Prime Contractor:** American Bridge/Fluor Enterprises, a JV**OSM Departure Time:** 1900**Contractor:** Zhenhua Port Machinery Company, Ltd (ZPMC)**Location:** Shanghai, China**CWI Name:** Li Yang and Zhu Zhong Hai**CWI Present:** Yes No**Inspected CWI report:** Yes No N/A**Rod Oven in Use:** Yes No N/A**Electrode to specification:** Yes No N/A**Weld Procedures Followed:** Yes No N/A**Qualified Welders:** Yes No N/A**Verified Joint Fit-up:** Yes No N/A**Approved Drawings:** Yes No N/A**Approved WPS:** Yes No N/A**Delayed / Cancelled:** Yes No N/A**Bridge No:** 34-0006**Component:** OBG Trial Assembly**Summary of Items Observed:**

Orthotropic Box Girder (OBG) at Trial Assembly Areas

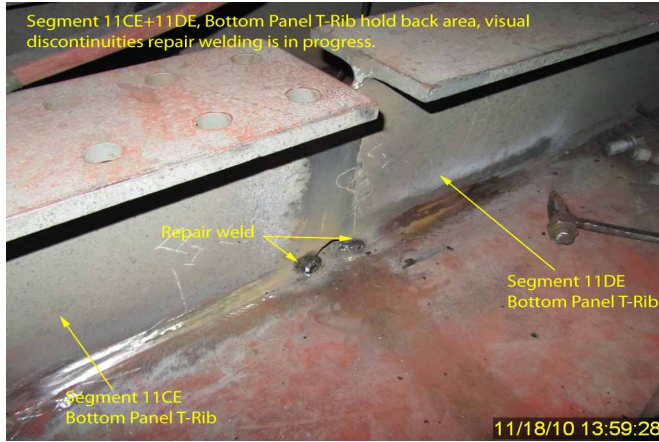
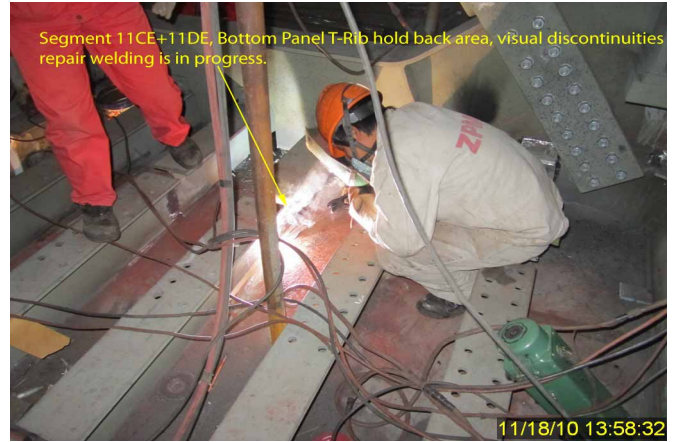
Please reference the pictures attached for more comprehensive details.
